2002 Annual Compliance Report Mexican Hat, Utah, Disposal Site

Compliance Summary

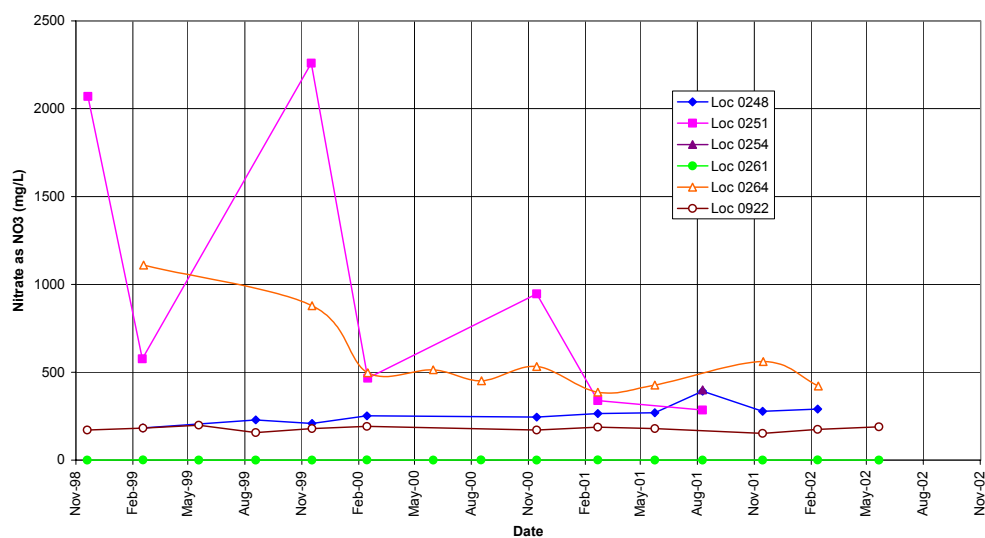
Figure 12–2. Time-Concentration Plots of Nitrate (as NO_3) in Seep Water at the Mexican Hat, Utah, Disposal Site

Concentrations of nitrate have been variable in the two North Arroyo seeps for the past 3 years and have declined substantially from greater than 2,000 mg/L to less than 500 mg/L (Figure 12–2). Nitrate concentrations have remained relatively stable in the Gypsum Creek seeps for the past 3 years ranging from 150 to 400 mg/L. Concentrations in the background seep remain below 1.0 mg/L.

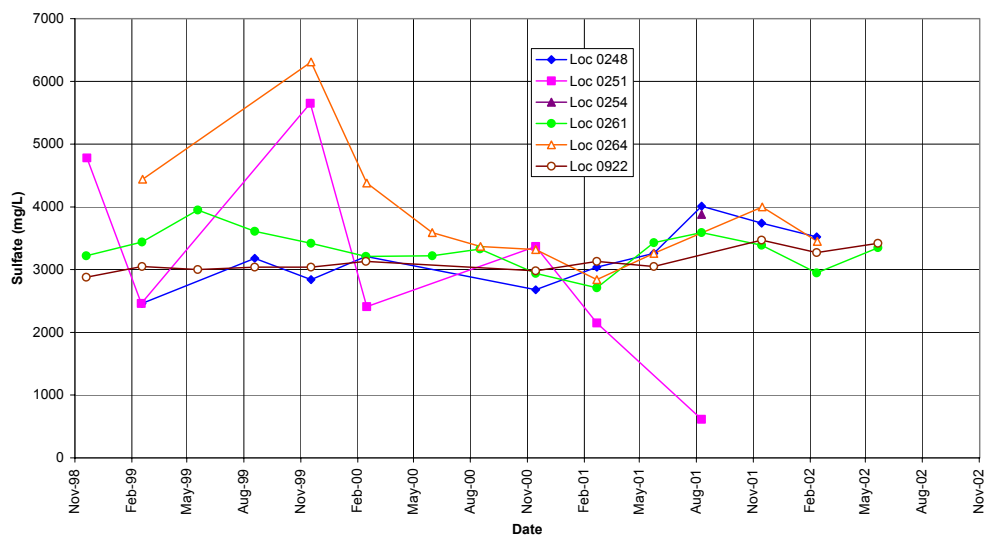
Figure 12–3. Time-Concentration Plots of Sulfate in Seep Water at the Mexican Hat, Utah, Disposal Site

Sulfate concentrations similarly have decreased in the two North Arroyo seeps from greater than 6,000 mg/L to less than 4,000 mg/L (Figure 12–3). Concentrations in the Gypsum Creek seeps and the background seep have remained relatively steady between 3,000 and 4,000 mg/L during this time.

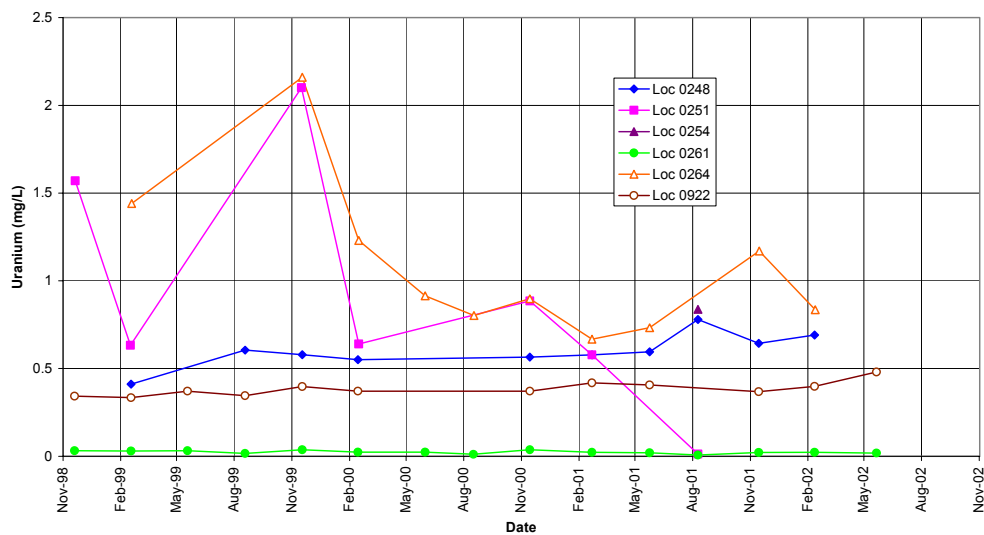
Figure 12–4. Time-Concentration Plots of Uranium in Seep Water at the Mexican Hat, Utah, Disposal Site

Concentrations of uranium in the North Arroyo seeps have decreased from greater than 2.0 mg/L to less than 1.0 mg/L since November 1999 (Figure 12–4). Concentrations remain relatively constant in the Gypsum Creek seeps at approximately 0.5 mg/L. Background levels at seep 0261 averaged 0.024 mg/L for the past 3 years.

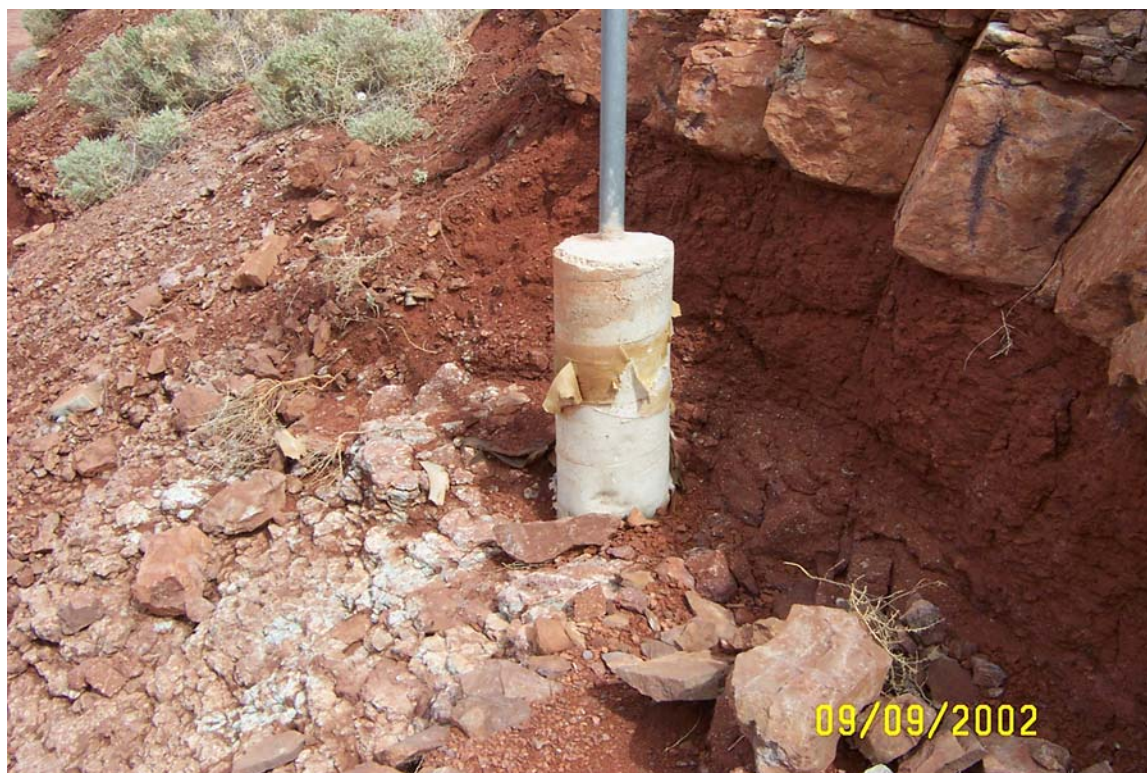
There are 43 perimeter signs and one entrance sign. All signs were legible. Although perimeter signs P24 and P26 have erosion at the concrete bases as noted in previous years, they remain stable. Perimeter sign P4 (PL-1) appeared unstable as approximately 3 feet of the concrete base was exposed and will be resecured or relocated.

PL–1. Erosion around perimeter sign P4.

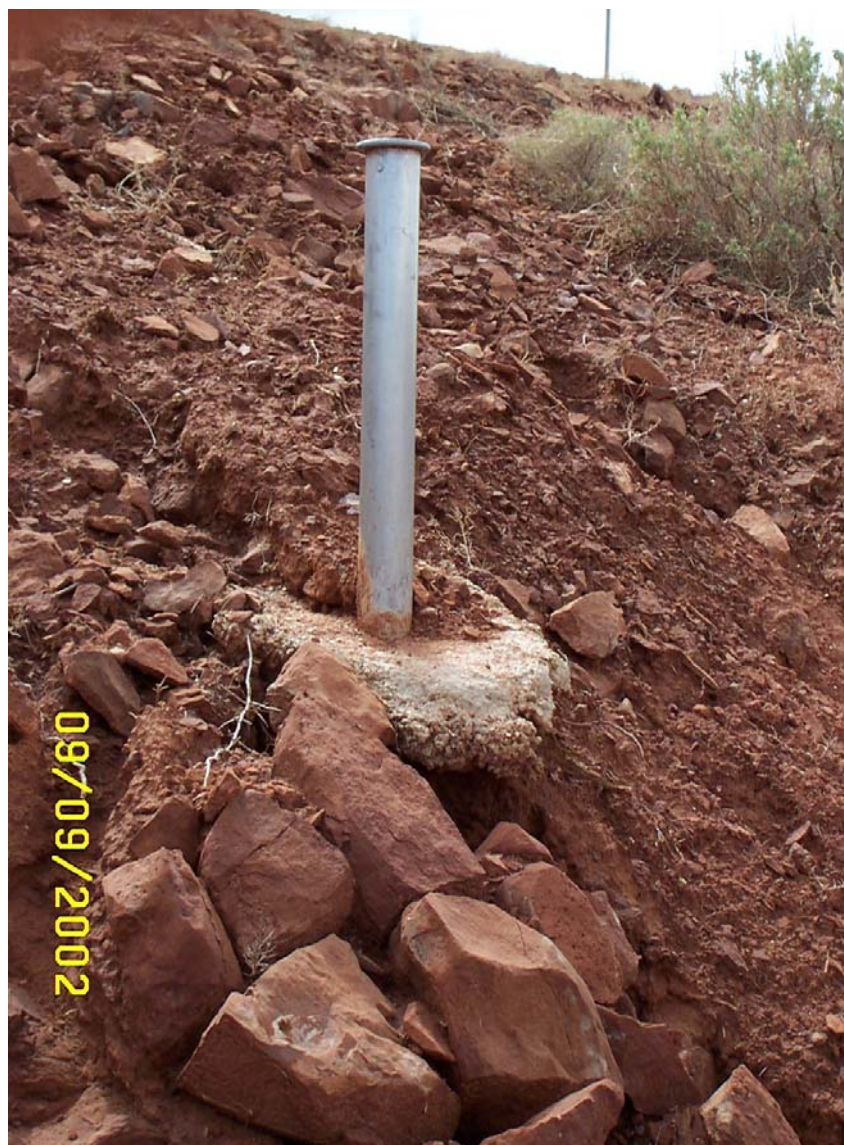
Boundary monument BM-11 (PL-2) is situated on a steep soil and rock slope, and soil has eroded from around the downhill side of the concrete base. The monument was stable but it will be resecured or reference monuments will be installed.

PL-2. Erosion around boundary monument BM-11.

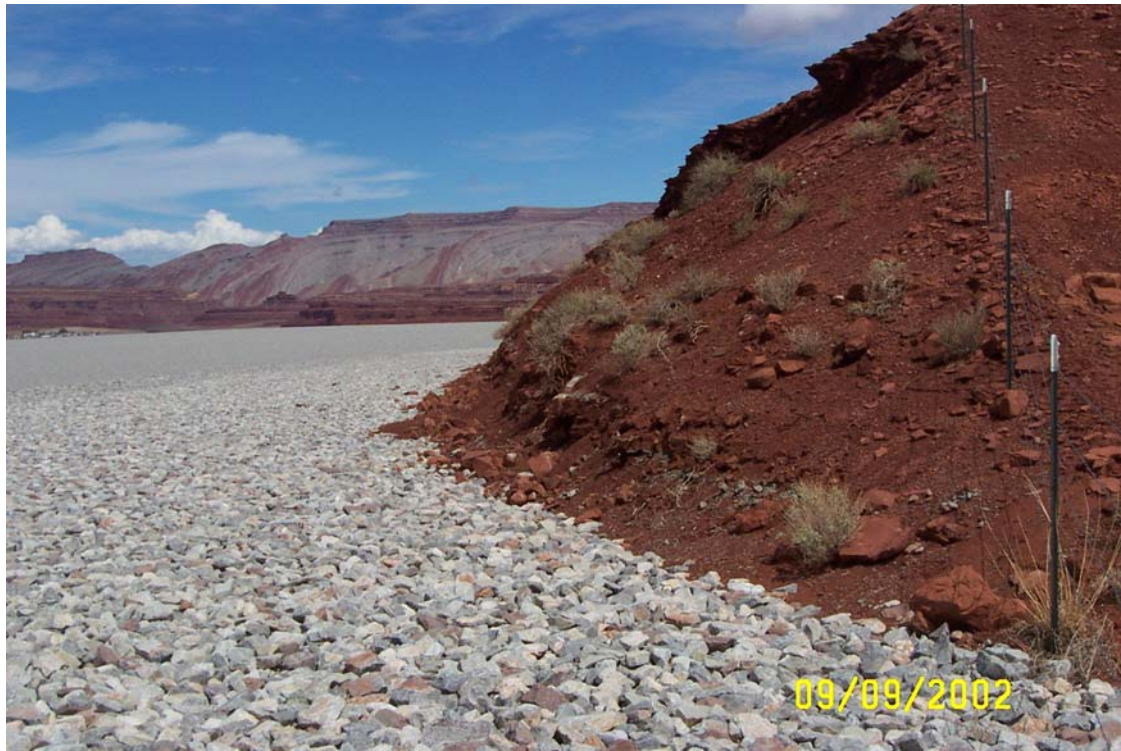
The sloughing of red country rock and soil along the south apron did not appear to have increased significantly during the past year; the accumulation remains approximately 18- to 24-inches high against the base of the vertical face of native rock. As in previous years, inspectors did not find evidence of channel erosion in this area, and the sloughed material does not appear to have filled the void spaces in the riprap beyond the toe of the slope. A baseline photograph (PL-3) was taken at a reference location established this year to determine trends. A photograph will be taken for the record annually until conditions stabilize.

PL-3. Rock and soil accumulation on south apron.

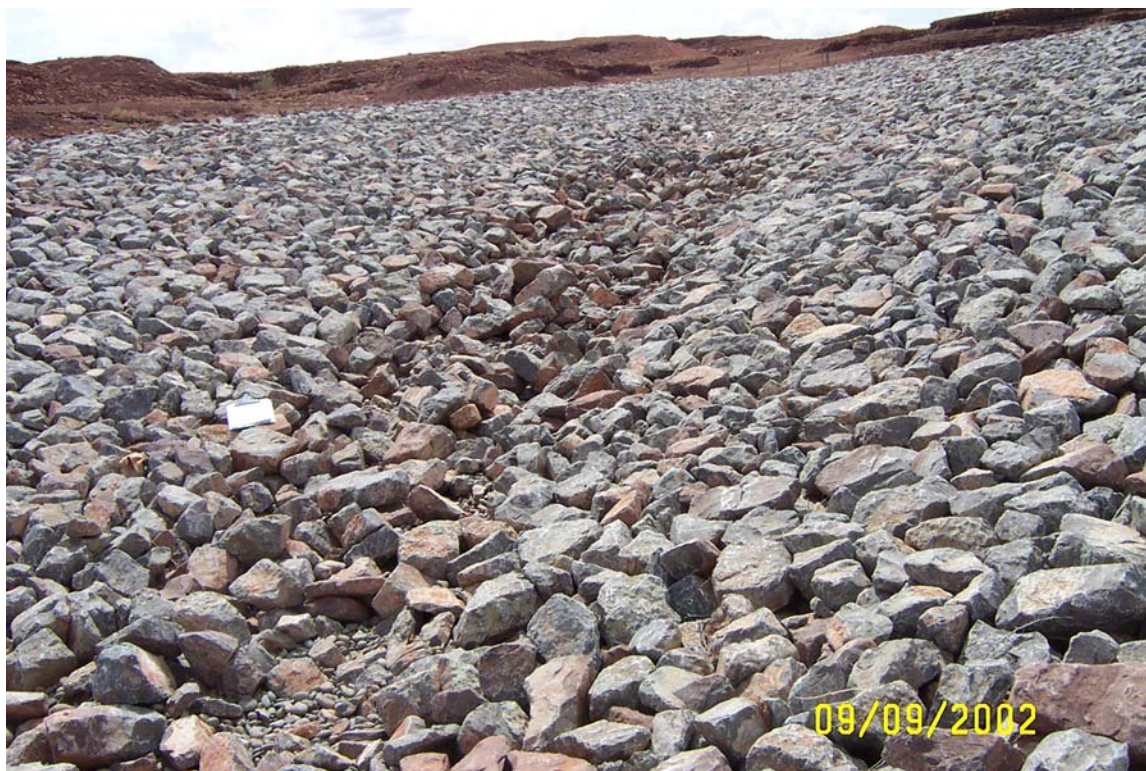
- 12A A severe storm passed through the Mexican Hat area on September 8, 2002, causing water from impervious areas south and west of the disposal cell to flow into the west diversion ditch. Municipal trash, tumbleweeds, and sediment were carried onto the site and became lodged in the security fence and diversion ditch riprap. Water depths in the ditch reached about 3 feet as indicated by the high water mark on the ditch sides. A 40-foot long by 3-foot wide section of

riprap at the south end of the ditch slumped to the bottom of the slope (PL-4). Erosion also occurred in the soft bedrock where the west ditch exits into the north arroyo. Inspectors saw no other evidence of creep, settling, erosion, burrowing, or other degradation in this transect.

PL-4. Rock that moved in the south end of west ditch during storm event.

- 12B A follow-up inspection by a geotechnical engineer was performed to evaluate the extent of damage caused by the storm. The recommendation is to rebuild the eroded portion of the diversion channel per original design.
